CATARACT CREEK DAM

Manual for Operation and Maintenance

**State Water Projects Bureau
Water Resources Division
Department of Natural Resources and Conservation
48 North Last Chance Gulch
P. O. Box 202301
Helena, MT 59620-2301**

**Initial Publication May 1995
Revised May 2001**

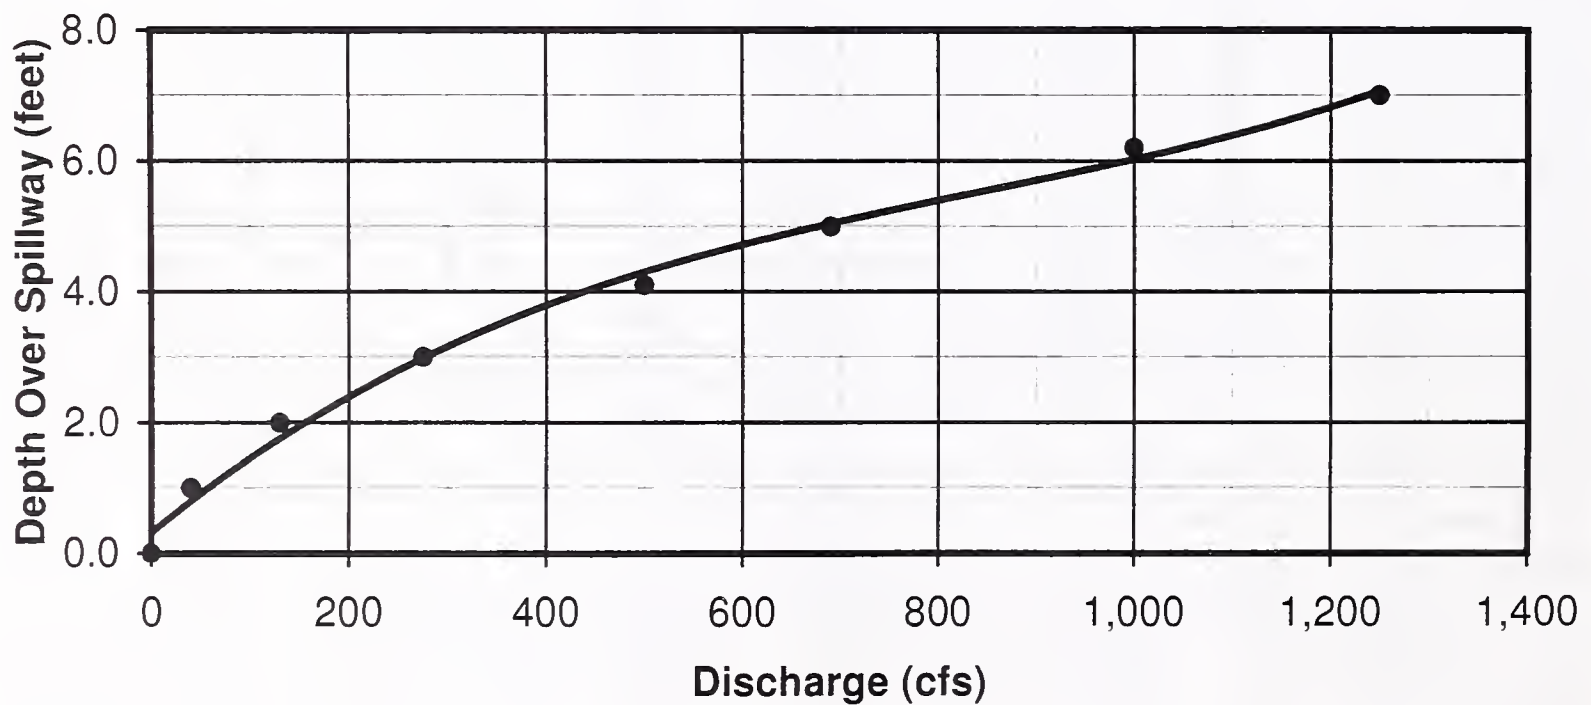
CATARACT DAM SPILLWAY RATING CURVE

Depth Over Crest (feet)	Elevation (feet)	Discharge (cfs)
0.0	6,353.0	0
1.0	6,354.0	40
2.0	6,355.0	130
3.0	6,356.0	275
4.1	6,357.1	500
5.0	6,358.0	690
6.2	6,359.2	1,000
7.0	6,360.0	1,250

Note: Data from the Corps of Engineers Phase 1 Inspection Report (1980).

bottom. When the spillway spills, the water has eroded a large cut where the channel drops into Cataract Creek. The maximum capacity of the spillway is 1,250 cfs.
